## 1955-57 UPPER MAST JACKET REBUILD

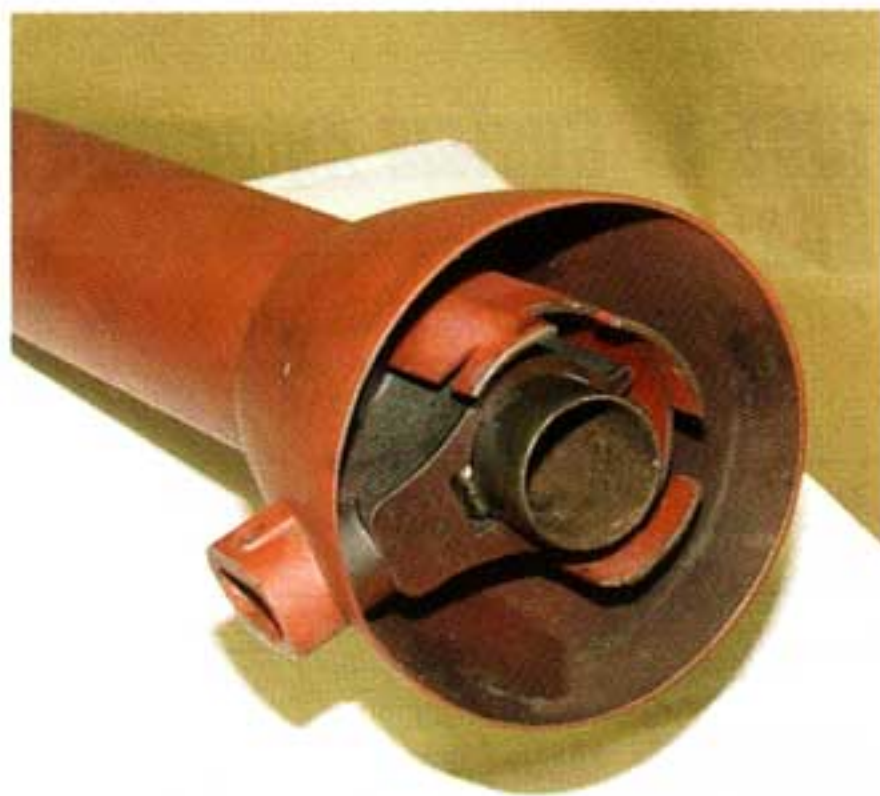
**Photo #3:** The shift collar will slide onto the shift tube and key into place. Use a small amount of grease on the shift tube to allow the shift collar to slide freely. Make sure the shift collar is slid down all the way.

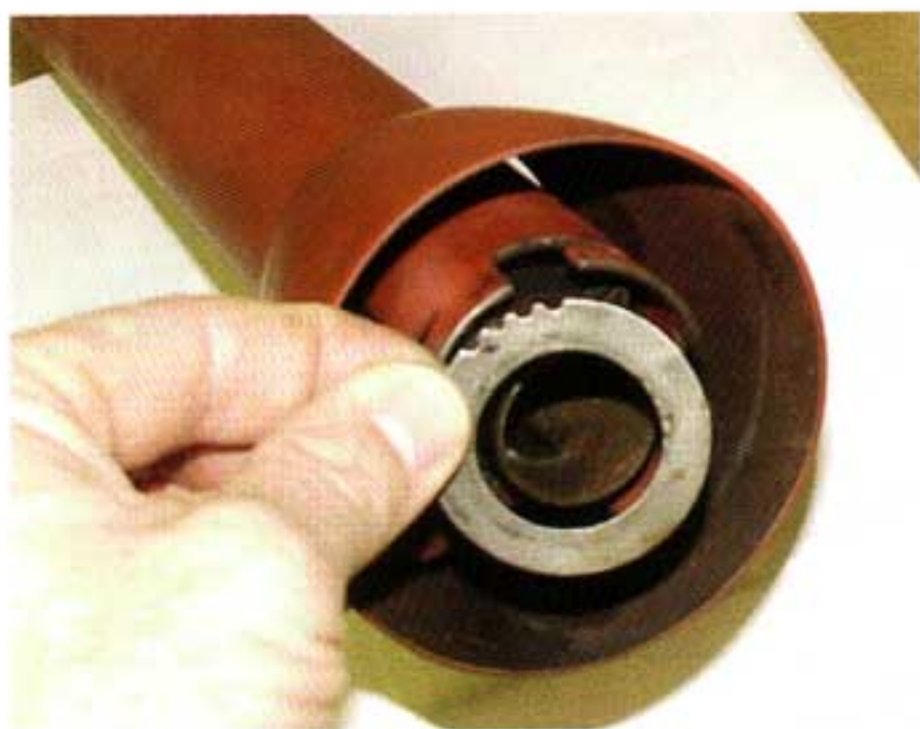
**Photo #4:** Next install the notched thrust washer #53-49. Once again, use a small amount of grease on the top and bottom of the thrust washer.

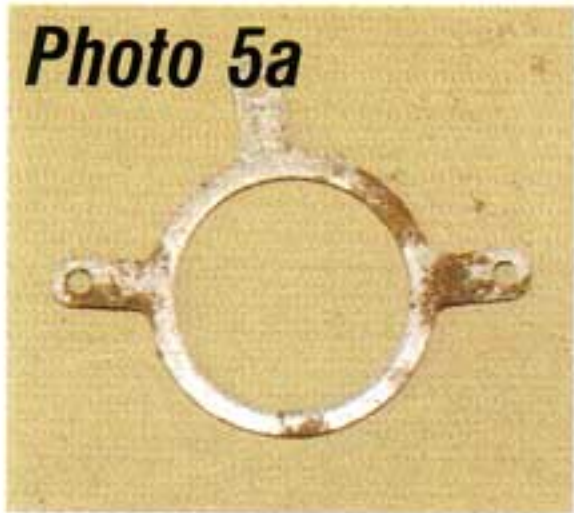
**Photo 5a**

**Photo #5a & 5b:** A new turn signal locking plate is included in the upper steering column rebuild kit. The locking plate keys into the top of the mast jacket to hold the turn signal housing in place. This plate can only be installed in one direction.

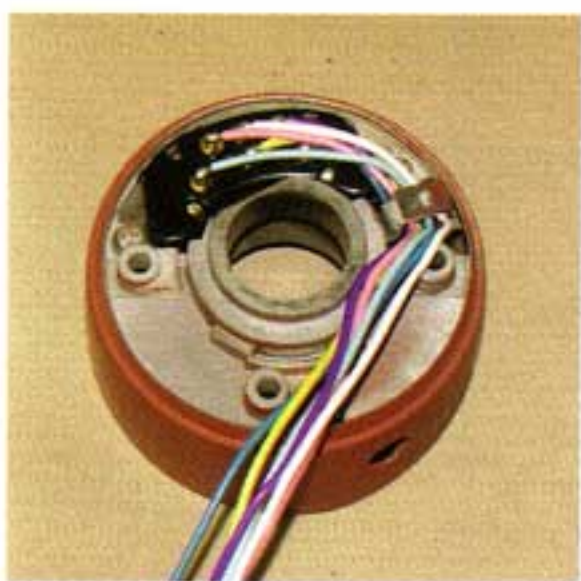
**Photo #6:** Before installing the turn signal housing, be sure the turn signal switch and wires are in good working order. Replace if necessary. The turn signal switch #22-09 is held to the bottom of the turn signal housing with two #8 machine screws. There is a spring steel clip to keep them in place.

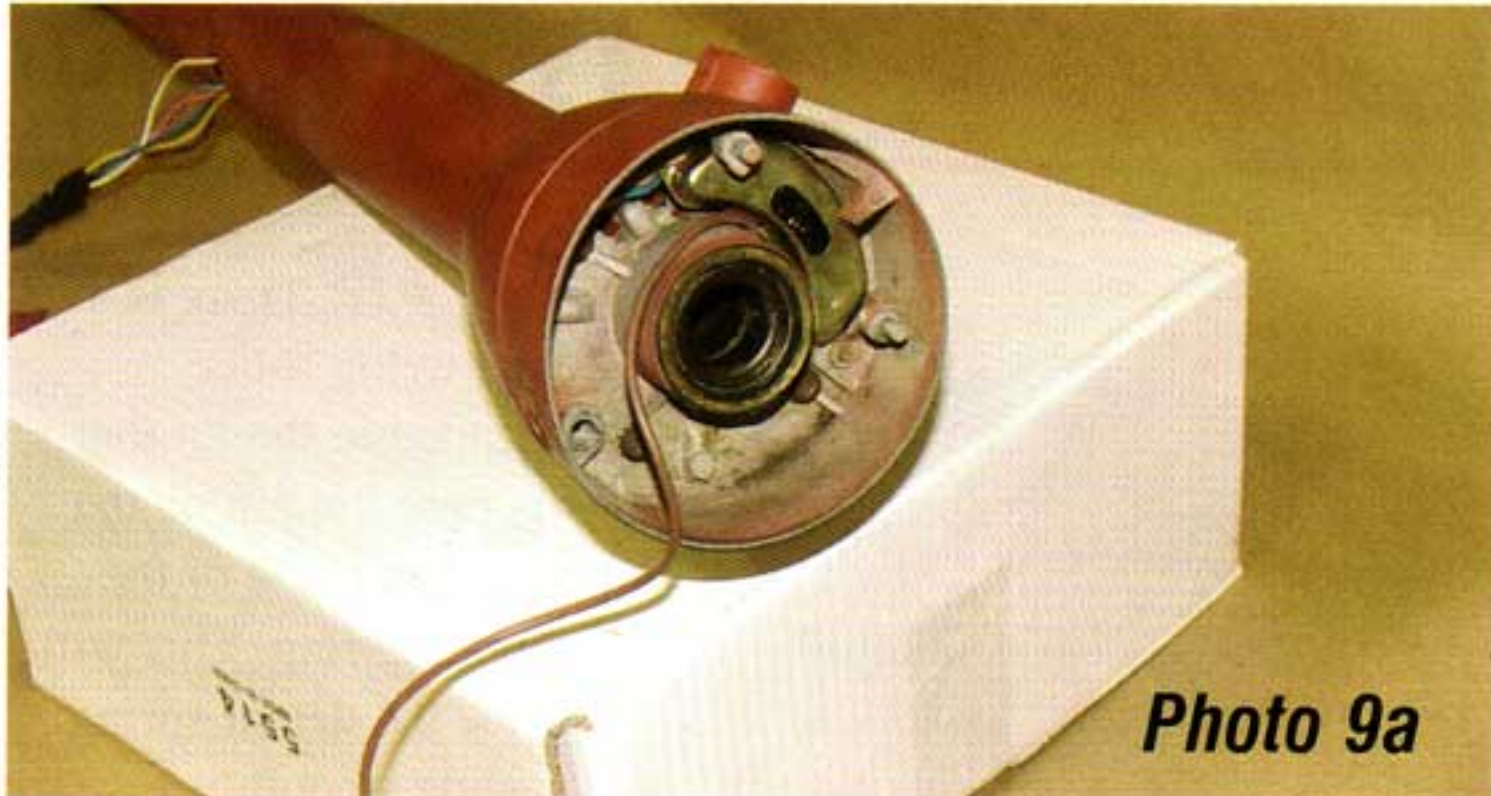
**Photo #9a & 9b & 9c :** The upper steering column bearing and wire #53-21 fits into the upper part of the turn signal housing. On 1955-56 cars, the wire will need to be fed down through the mast jacket also. You may also install this bearing in the turn signal housing prior to step #8 if you wish.

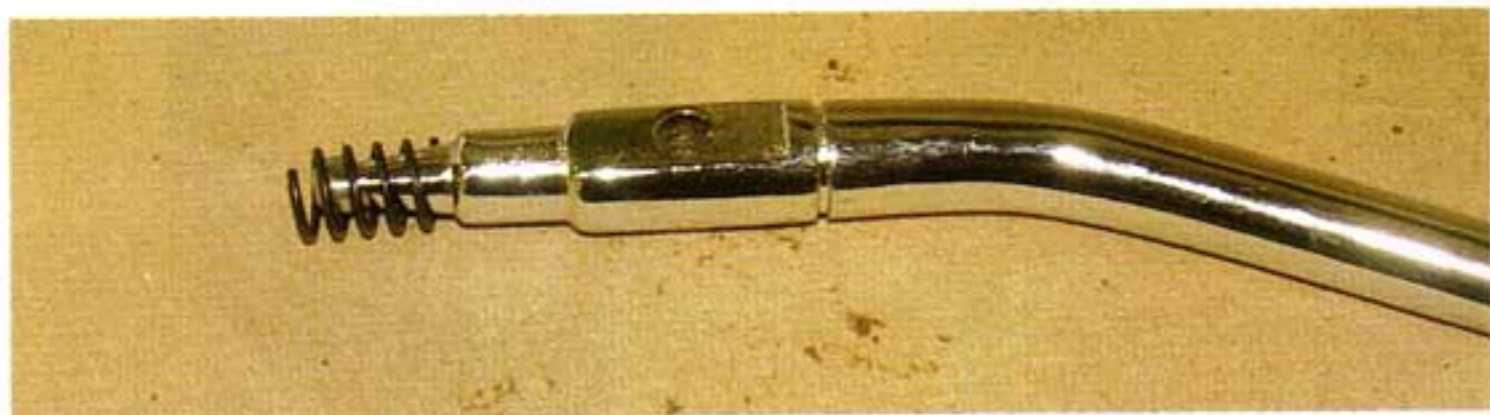
**Photo #17:** The column shift lever #06-60 has a spring #06-05 at the bottom to keep tension on the lever. Place a small amount of grease on the tip of the lever and inside the hole where the roll pin will go.

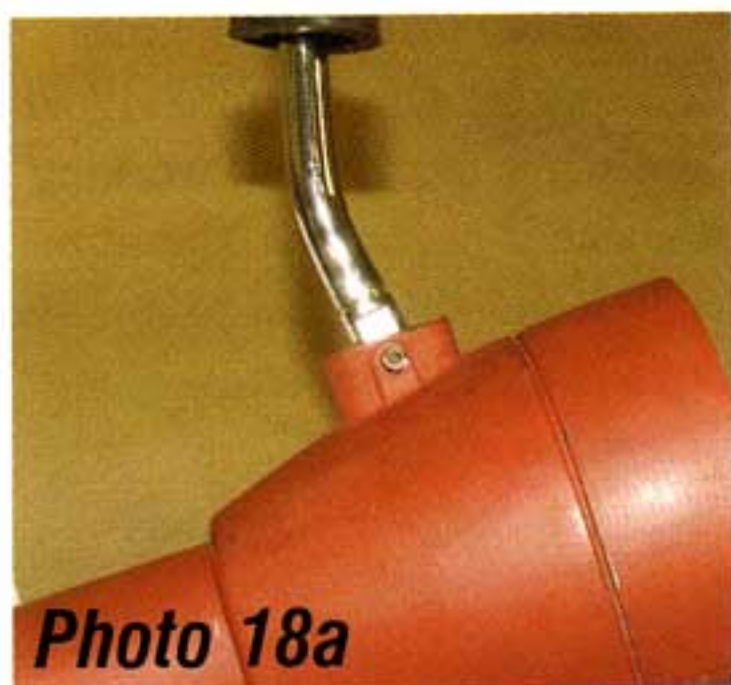
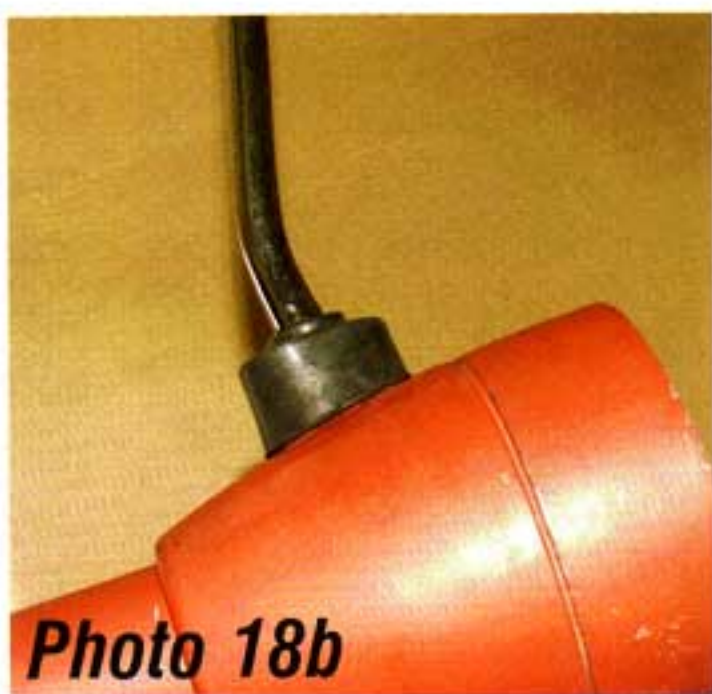
**Photo #18a & 18b:** The column shift lever is held to the shift collar with roll pin #06-25. Slide the shift lever grommet #09-02 up onto the lever. Push the lever into the shift collar and install the roll pin, making sure the lever engages the hole in the inner shift tube. Pull the shift grommet into place to cover the roll pin and boss on the shift collar.

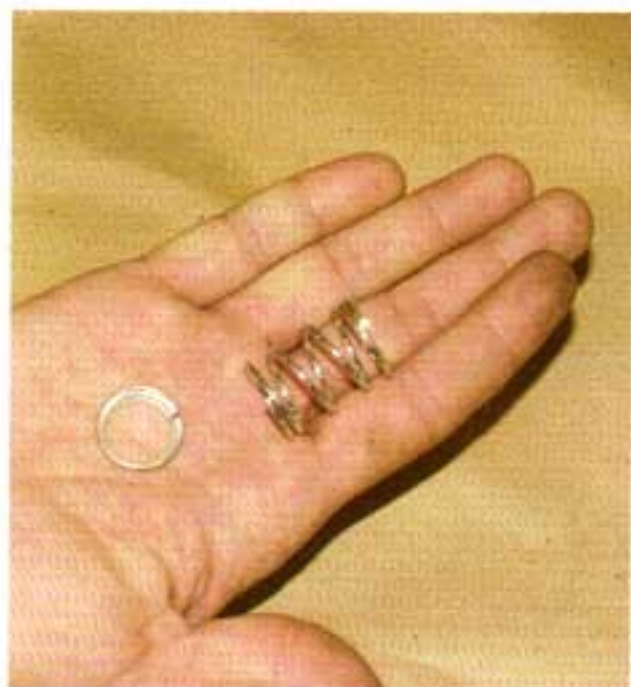
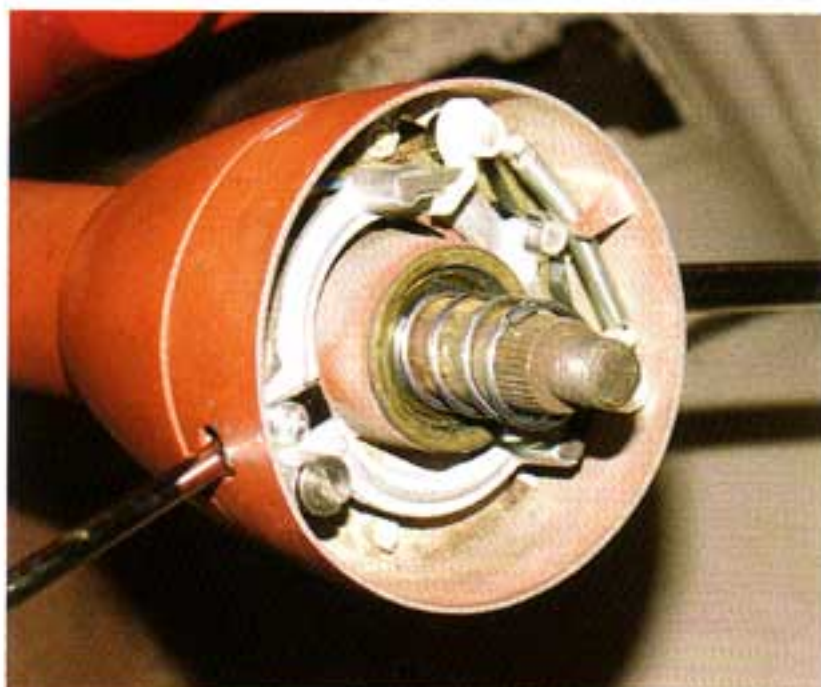
**Photo #20a & 20b:** The upper steering column bearing #53-21 includes a spring and split ring bearing seat. With the mast jacket mounted in the car, slide the bearing seat down onto the steering shaft and then the spring. This assembly will be trapped under the steering wheel, thus keeping a load on the upper steering column bearing.

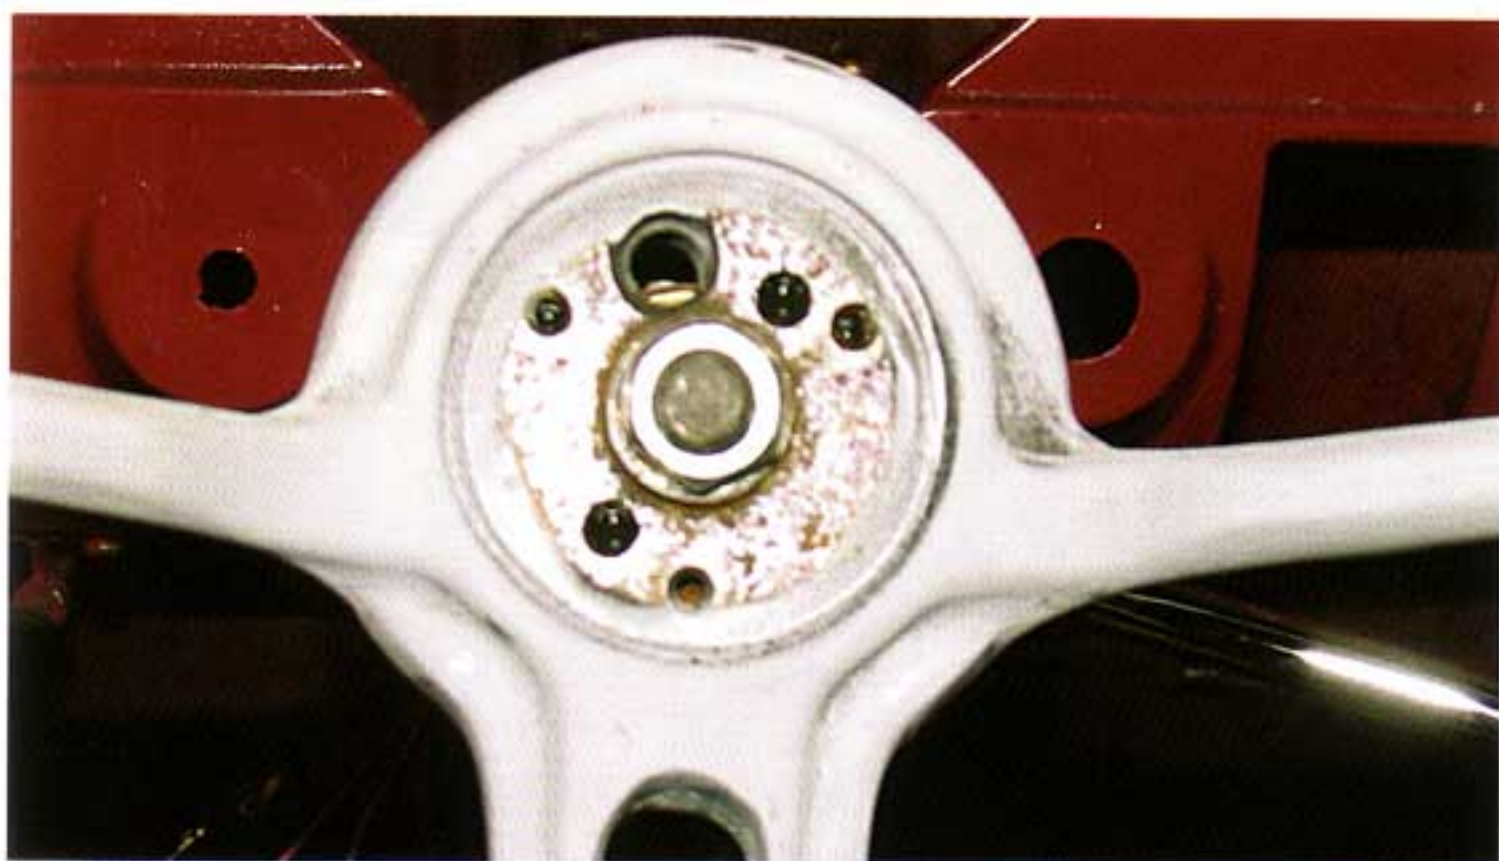
**Photo #21:** After aligning the mark on the steering wheel with the mark on the top of the steering shaft, install the steering wheel onto the steering shaft using the flat washer and nut supplied with the kit. Torque to 45 lbs.

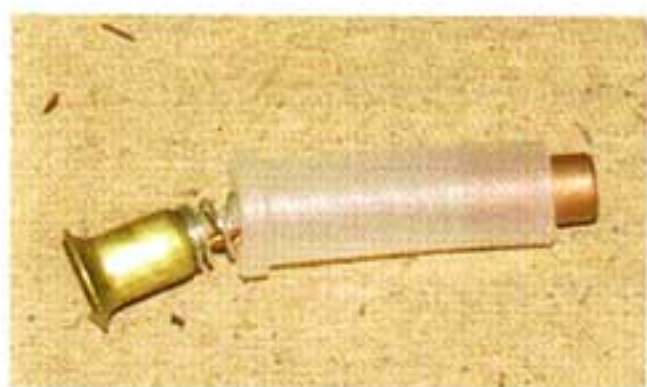
**Photo #22a & 22b:** The horn connector included in the upper column rebuild kit drops through the large hole in the steering wheel and makes contact with the contact ring on the upper steering column bearing.

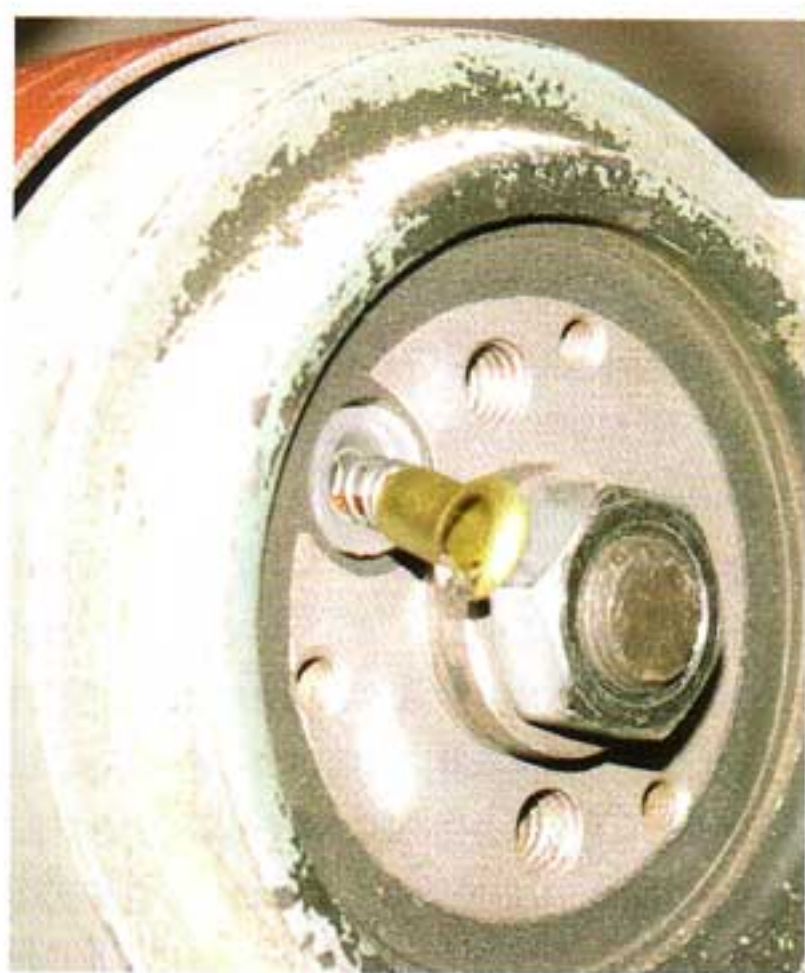
**Photo #23:** The Bellville washer is the spring steel plate that fits between the plastic horn ring insulator and the steering wheel hub underneath the chrome horn ring. When the horn ring is pushed it will cause the Bellville washer to ground to the steering wheel center hub causing the horns to blow. Make sure the Bellville washer is installed with the arch upward towards the horn ring insulator. Also be certain the center of the steering wheel where the Bellville washer will make contact is bare metal, free of rust and paint.

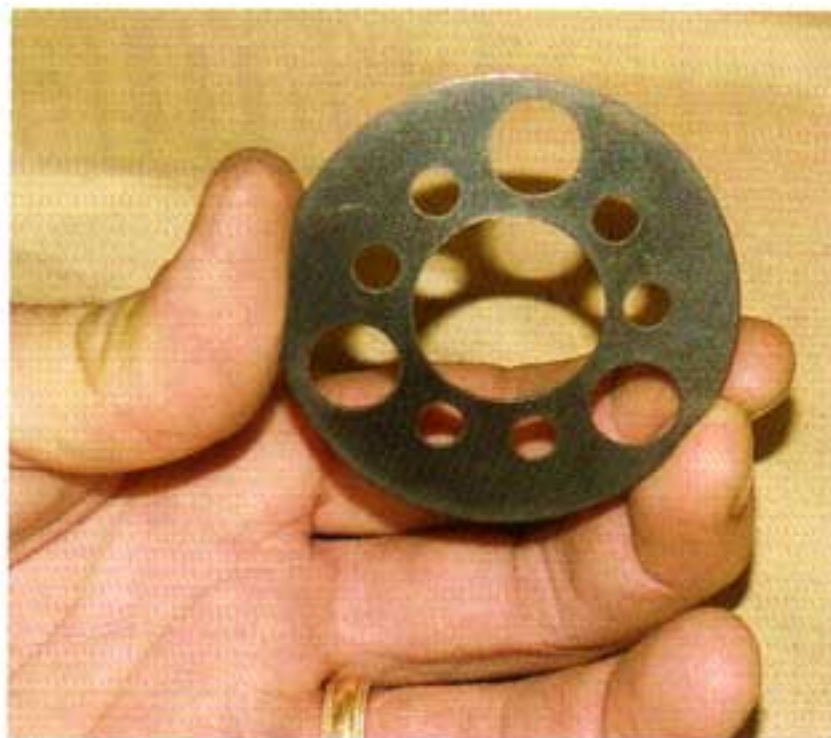
**Photo #24:** After the Bellville washer, install the horn ring insulator.

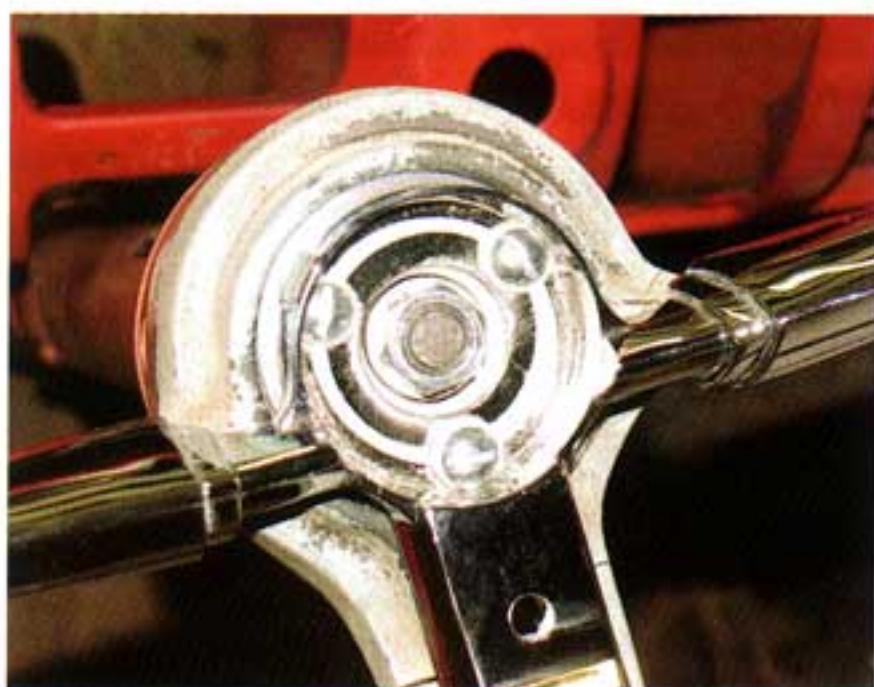
**Photo #27:** Once everything is installed and the horn is working properly, install the horn center cap.
