# Tech Help

## Do it yourself!

### Repairing lower door rust

### Door Repair and Re-skinning

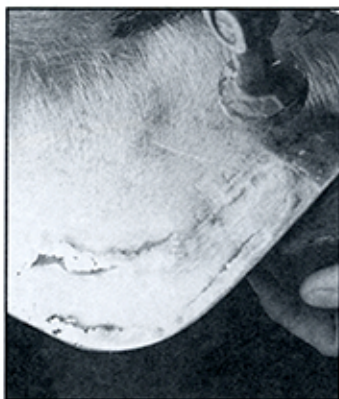
Photo #7

3. Using the rusty piece that was removed from the door, cut a repair panel the same shape out of original gauge steel (we like to use a junk hood to remove steel patches from) and trim it to a size that is just slightly smaller than the area to be repaired. Carefully position the patch in the door and tack weld it into place using a MIG welder on low power. (See Photo #6.) Solid weld the piece into place a stitch at a time, being careful not to over-heat the door metal. Keep in mind that the larger the area to be cut out is, the more likely it is that the door metal will distort when welding. Be very, very careful to weld a little at a time and allow the door metal to fully cool to avoid distortion! Once the piece is solid welded, grind the welds smooth and hammer and dolly out any distortion. (See Photo #7.)

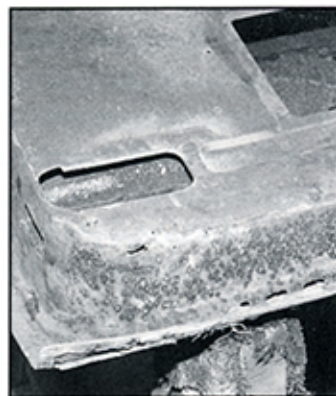
Photo #15

6. Some doors are too heavily rotted to be patch repaired as we did our driver side hardtop door. [Photos #15 and #16](#) show the bottom of our passenger side hardtop door that was very heavily rusted. The inner door bottom was very badly rusted, as well as the lower outer skin. There was no way to properly repair this door without replacing all of the rusty sheet metal. Our door will receive an inner door bottom, [Part #31-132](#) and a full door skin, [Part #31-30](#).

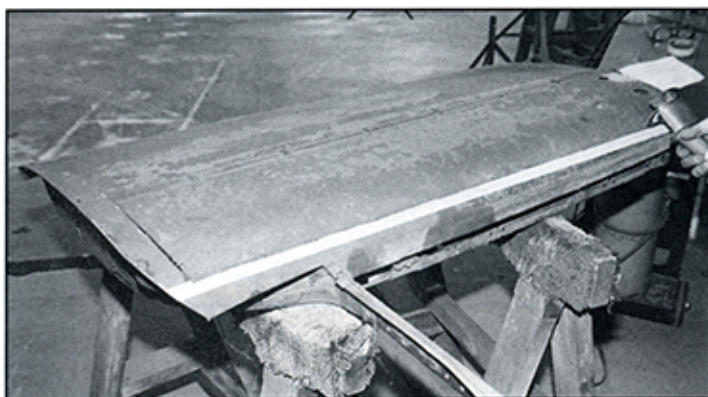
Photo #17

7. No cutting or removal of the original sheet metal should be done until the new panels have been obtained and compared to the areas to be repaired. This will prevent you from removing too much metal and having to start over with another door or fill in any gaps that may be left! Once you have obtained the new repair panels, remove the original skin from the door. If you are installing a full door skin, remember that the top inner beltline stainless lip is not included on the replacement panel. We chose to cut the door about 3 inches down from the top edge. (See [Photo #17](#).) Once the old skin is removed, your door will look like ours does in [Photo #18](#).

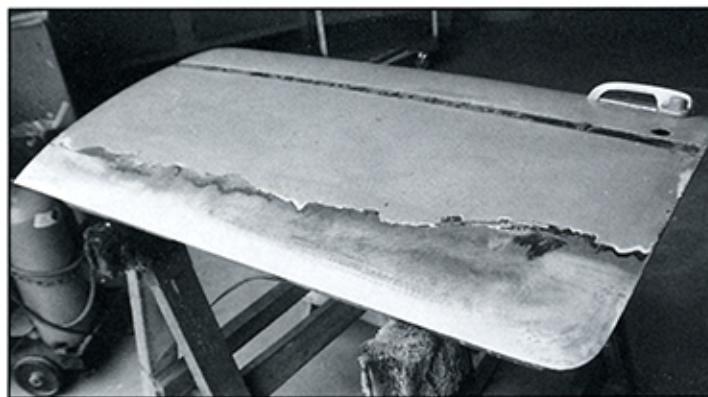
Photo #13

5. Any areas that have only small pinholes should be welded up and ground down so that the entire door bottom has been repaired. Once the door has been fully repaired, it should appear as ours does in Photo #13. After all welding and grinding is complete, apply a thin coat of All-Metal body filler, Part# 49-28 to the repaired areas and sand smooth. (See Photo #14.) Check the fit of the door on the car to be certain you have not disturbed the edges of the door. The inside of the entire door should be treated with Part #49-51 POR-15 metal ready spray and Part #30-52 POR-15 rust preventative paint to prevent any future rust. Finish the bodywork, prime and paint the door.

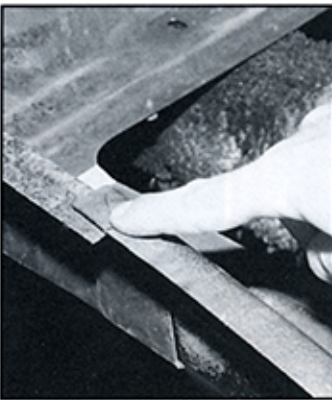
Photo #25

10. Remove the door frame assembly from the car for permanent welding. At the rear edge of the door, the new panel overlaps the original frame on the outside. This small area should be cut out so the edge can be butt welded. (See Photo #25.) This will allow the new skin to fit the edge of the door frame properly. At the front edge of the new door bottom, there will actually be a small gap at the edge seam between the new piece and the original door frame hinge area support. (See Photo #26.) Clamp the edge to achieve proper fit and stitch weld the entire new door bottom in place. Install the door assembly on the car again and check the edges for proper fit. (See Photo #27.)

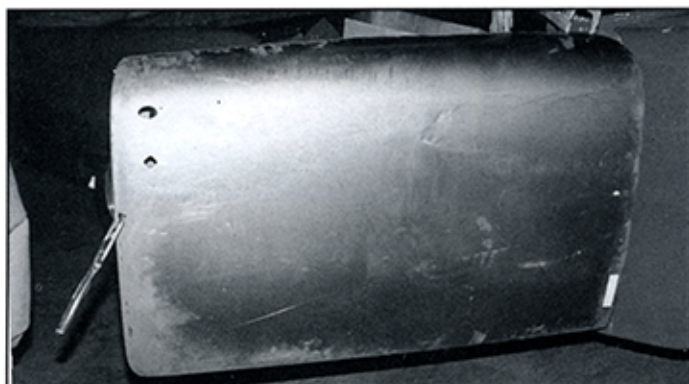
Photo #28

11. Reinstall the door frame on the car and adjust. With the door frame assembly in the open position, clamp the replacement door skin in place. (See Photo #28.) It will be necessary to notch the top of the skin to fit around the vent window post. Mark this area with a pencil (See Photo #29) and remove with a cut-off tool. With the new skin clamped in place, mark a line along the top with masking tape about 2-inches down from the top edge of the replacement skin. (See Photo #30.) Cut along this line through the replacement skin and through the original skin, creating a butt seam. (See Photos #31 and #32.) Do not weld the skin to the door at this time.
