1955-57 FULL FLOOR INSTALLATION

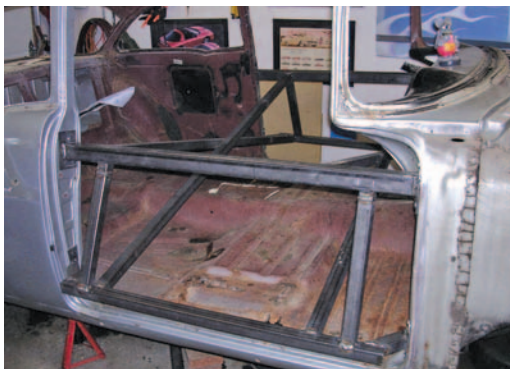
Photo #1: The floors and braces of this 1956 two door sedan were pretty rusty and would require major surgery. Before the body was removed from the frame we fashioned a bracing system to keep everything square just in case we had to remove the whole floor.

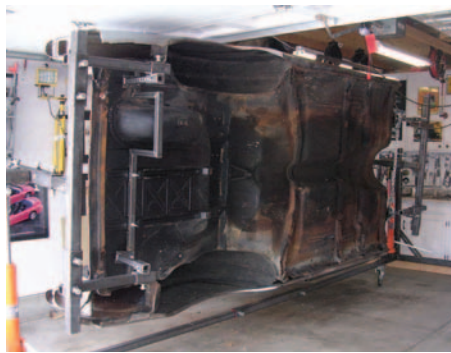
Photo #2: Once the body was on the rotisserie we could see all the body braces were rusty. In addition to several holes in the floor pans, the inner and outer rockers were full of holes as well. At this point we

ruled out replacing the pans and braces in sections and realized it would be better to replace the floor as a single unit, complete with braces and inner rockers.

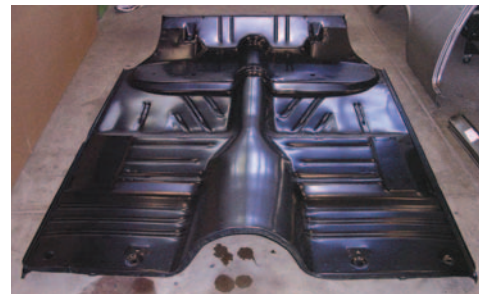
Photo #3: The new floor P/N 31-279 came with nearly everything we needed. Always have the new sheet metal on hand before cutting out the old!

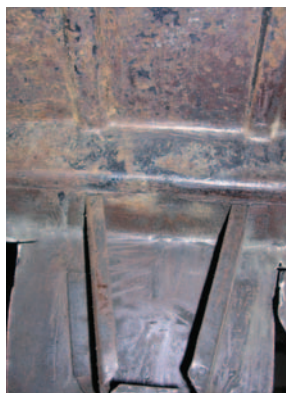
Photo #4: We planned to cut out the old floor in sections, approximately one inch or so inside of the existing flanges. Plan to cut around the upper rear axle bumper mount. This mount will have to be carefully removed and welded to the new floor.

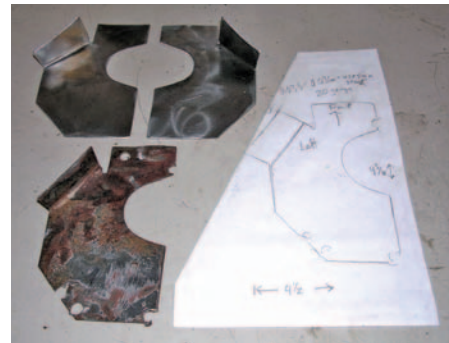
Photo #5: Plan to cut around the small braces that hold the bottoms of the kick panels. These will have to be removed from the old floor and welded to the new floor. The right side one was rusted to pieces, but the left one was in pretty good shape and served as a pattern to fabricate both sides in fresh 20 gauge metal.

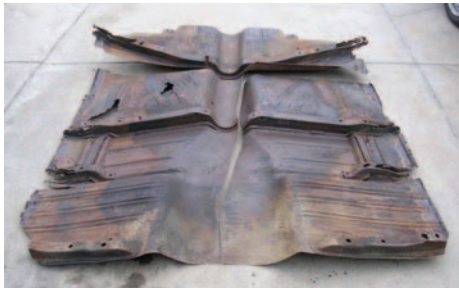
Photo #6: We used a reciprocating saw to cut out the old floor approximately one inch inboard of the original flanges. The old floor clearly had some issues!

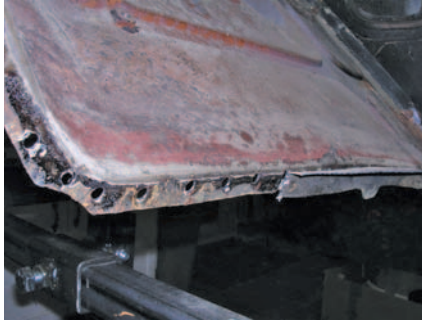
Photo #7: With the old floor out of the way, the old spot welds attaching the old floor flange to surrounding metal were drilled out with a 1/4 inch pilot point bit. We chose not to use a spot weld drill bit because we would later plug weld through these holes from the outside. After drilling, the old floor flange was removed with a chisel.

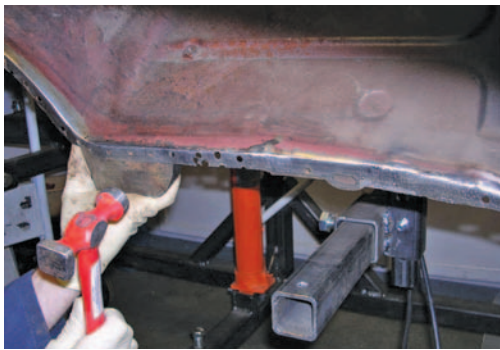
Photo #8: The flange was then cleaned of old seam sealer with lacquer thinner and straightened with a hammer and dolly.

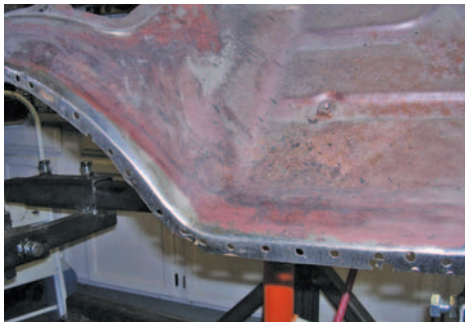
Photo #9: The flange should be clean and straight like this all the way around the perimeter of the floor in preparation for welding.

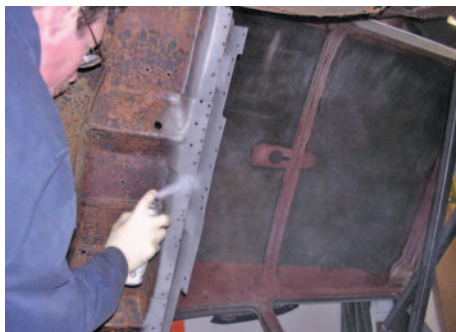
Photo #10: The entire flange was then coated with a weld-through primer.

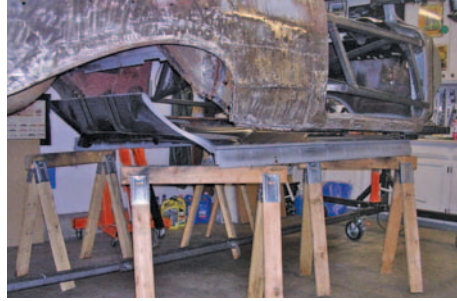
Photo #11: The new floor flanges were similarly prepped. They were sanded with 80 grit to remove the E-coating. Holes were punched along the top and bottom edges of the inner rocker that allow spot welding to the outer rockers later. All surfaces that were to be hidden inside welds were coated with weld-through primer. The body was then raised high on the rotisserie and the floor was placed on saw horses beneath it.

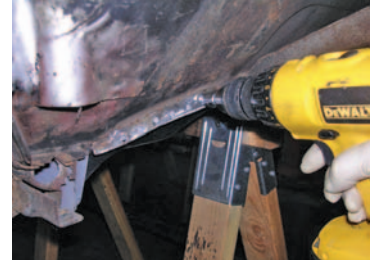
Photo #12: The body was lowered onto the new floor. The flanges were lined up to our liking. Some flange sections required a little hammer and dolly persuasion. The flanges were then screwed together with self-tapping sheet metal screws every few inches.

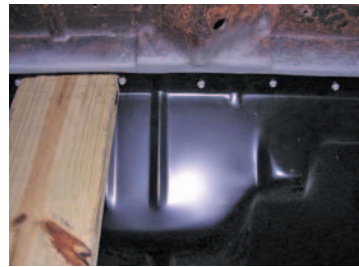
Photo #13: The rear flange was screwed to the trunk floor. This 2x6 plank provided a little extra persuasion to bring the floor flange up tight to the trunk flange.

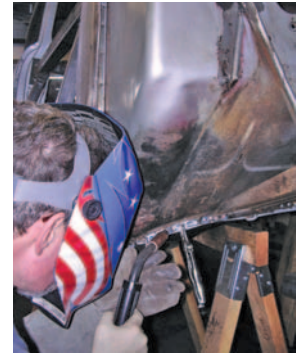
Photo #14: The flanges were then plug welded together. Vise grips help keep the flanges tight.

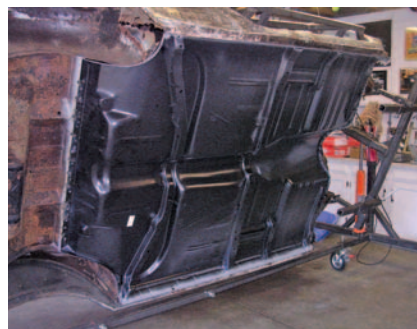
Photo #15: This is the almost finished project. Quite an improvement! The plug welds can be ground down until they look more like the factory spot welds if desired. Thanks to George Franklin #20000416 for the images and text. ✓
