## 1955-57 AUTOMATIC STEERING COLUMN SHIFT DETENT FOR TH200, TH350, TH400 AND 700R4

### Randy Irwin - Technical Writer

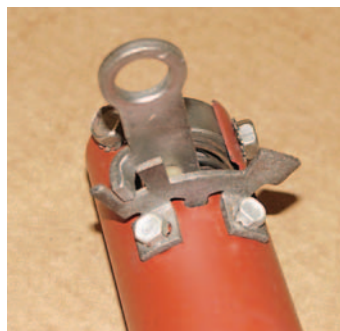
**Photo #1:** The original automatic steering column utilizes a bolt-on shifter detent at the bottom of the column available as P/N 19-38 or 19-39. This detent positively locks the column shift arm in the "Park" position, keeping the transmission safely locked into "Park".

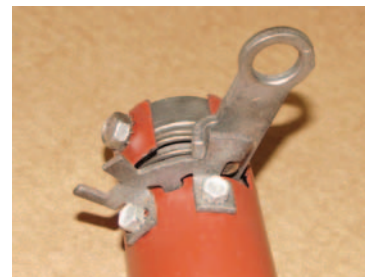
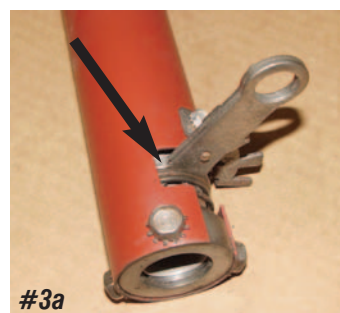
**Photo #3a & 3b:** There is more than enough room in the notch on the stock steering column mast jacket to allow the shift arm to travel far enough to operate a three or four-speed automatic transmission. If the original detent is modified to achieve the amount of travel needed to shift from overdrive to first gear, the original lower end of the detent will likely break off.

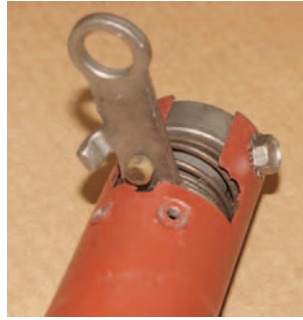
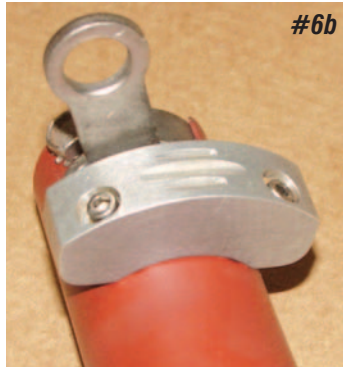
**Photo #4:** The new shift detent bracket P/N 53-370 or 53-370P is made of billet aluminum and includes stainless steel mounting hardware.

**Photo #5:** The stock column shift arm has a nylon button that makes contact with the original shift detent when moving through the gears. This nylon button will not be used with the new billet shift detent bracket and should be removed.
