1955-57 WHEEL TUBS

My 1956 two-door sedan project car had some very rusty rear wheelhouses, wheel tubs, and trunk walls. The car is being customized with a street/strip flavor, so originality is not a big concern. It has already been treated to a spring pocket kit **P/N 21-131** and is due for some very wide rear tires. This car needed so much sheet metal that the decision was made to use race car-style wheel tubs and to repair the trunk walls. The final result is a whopping 16" of tire width clearance between the inside of the quarter panel lip and the original frame.

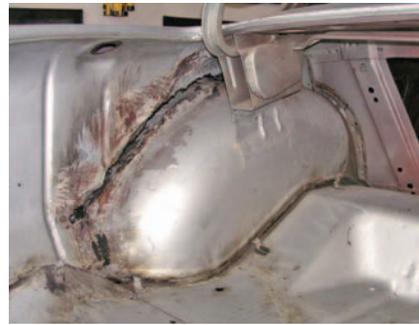
Photo #1: The trunk area of this car was in sad shape. The rear section of the original inner wheel tub had rusted away from the inner trunk wall. The rusty gap was over an inch wide and had been filled in by gobs

of body filler. The outer rear wheelhouse section between the rear quarter panel and trunk wall didn't look any better. The front section of the original inner wheel tub had similar rust problems. The outer front wheelhouse section was rusty as well. Rather than purchase a few thousand dollars of sheet metal to preserve the original look, the decision was made to go for a street/strip look for a lot less money. As one can see, this car had recently received a new floor. The rear seat back support will need to be removed to gain access to the tubs. Begin by drilling out the support spot welds with a 1/4 inch pilot point drill bit. Use a seam splitter to pop the welds loose, and remove the support.

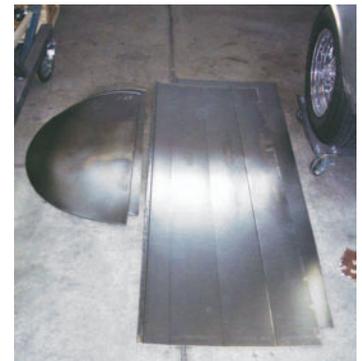
Photo #2: The tub kit **P/N 31-410** has four nearly flat pieces of 24 gauge steel. These include two semi-circular cheeks and two rectangular bands. Also in the carton will be two sheets of corrugated paper that will serve as band templates. Do not destroy the carton. It will be used to make the cheek templates.

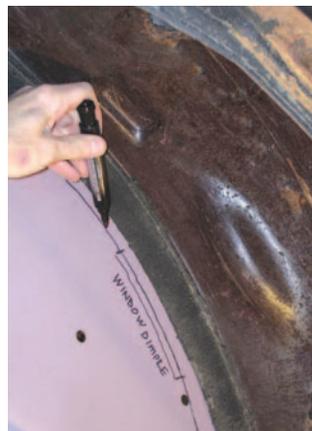
Photo #3: With the rear of the car up on jack stands, remove both rear wheels and the gas tank. Before cutting any sheet metal away, mark the inside of the outer quarter panel along the lower edge of the wheelhouse seal. The new wheel tub must meet the quarter panel near this line. Also mark the location and depth of the window dimple in the front wheelhouse section. This dimple allows necessary clearance for the rear corner of the rear quarter window.

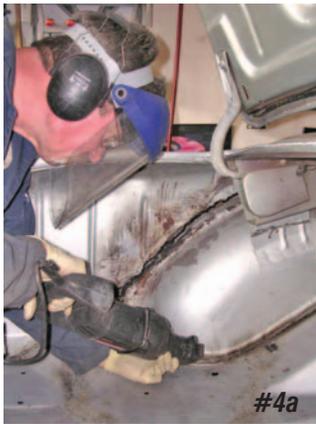
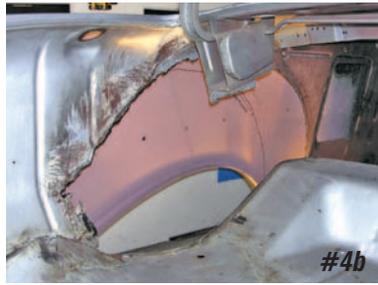
Photo #4a & 4b: A cut-off tool was used to sever the support between the original inner wheel tub and the trunk hinge box. Always use proper safety equipment.

Photo #4a: We used a reciprocating saw to cut the tub from the trunk floor. For the cuts along the inboard and rear sides of the tub, cut the

floor and leave the floor to tub flange attached to the tub. At the front of tub we preserved the outboard 8" of the floor flange to become an attachment point for the new tub. Drill out the spot welds holding the front of the tub to the floor. Use a seam splitter to separate the front side of the tub from the floor.

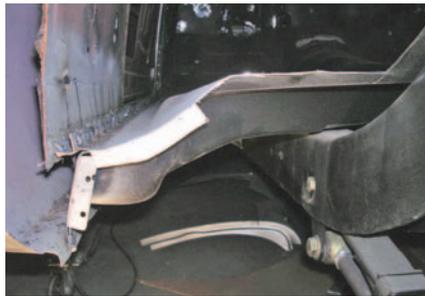
Photo #5: This is the preserved floor flange section. This flange has no holes drilled though it because this is a brand new floor and had never been spot welded to the original tub. If your rear

wheelhouse extensions (mud flaps) are in good shape you may want to preserve them as well. Leave them attached to the quarter panel at the rear. Cut the extensions away from the rear wheelhouse section with a horizontal cut at trunk floor height. If your rear wheelhouse baffle is in good shape you might wish to preserve it too. This baffle seals the upper inner quarter panel keeping dust, heat, cold, and tire smoke from making their way into the passenger compartment. The baffle is welded to the inner trunk wall and to the top of the rear outer wheelhouse. Cut the baffle away from the wheelhouse, leaving it attached to the trunk wall.

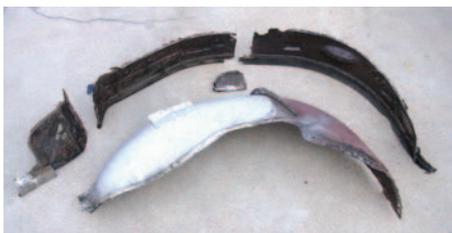
Photo #6: These are the removed components of the original sheet metal from the left side of the car. The small piece in the middle

is the baffle. This baffle was badly rusted and new ones are not available for this body style. The baffle on the right side of this car was missing entirely. New baffles will be fabricated. The piece on the far left is the original rear wheelhouse extension. It was in pretty good shape, but the right side one on this car was missing. New extensions, P/N 31-89 and 31-90, will be used.

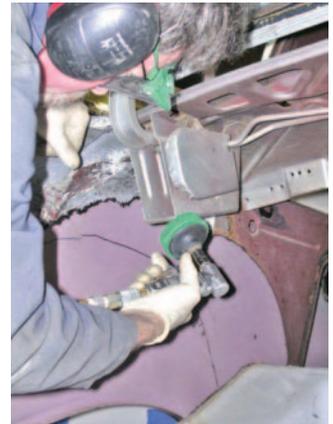
Photo #7: This was a good time to remove the paint from the lower portion of the hinge box using a 3M Green Roloc bristle disc on a pneumatic die grinder. These discs are great for removing paint without grinding away too much metal. The metal on this car was already thin enough! The lower portion of the hinge box was then coated with weld-thru primer, SEM 39783. Rather than repeating this many times, suffice it to say that all metal pieces need to be clean and bare prior to welding. The metal should also be coated with weld-thru primer if the backside metal surface will not be accessible after welding.

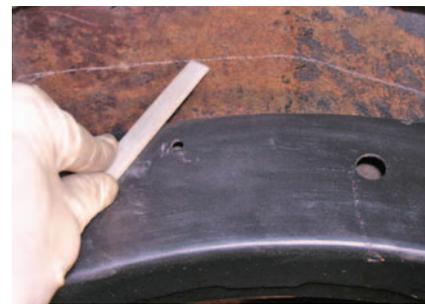
Photo #8: Working from under the car, mark the underside of the trunk floor along the outboard edge of the frame. We are using a flat soap stone which left a good visible line.

We used a cut-off tool to make cuts through the trunk floor every few inches along the line.

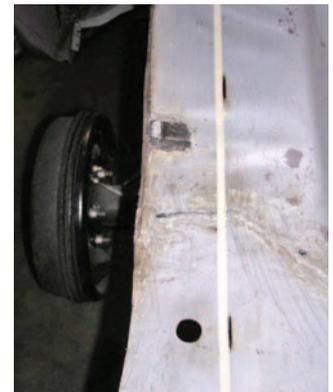
Photo #9: On the top surface of the trunk floor the cuts were connected with a length of tape to mark a continuous cut line. This cut will be parallel to and directly above the frame's outboard edge.

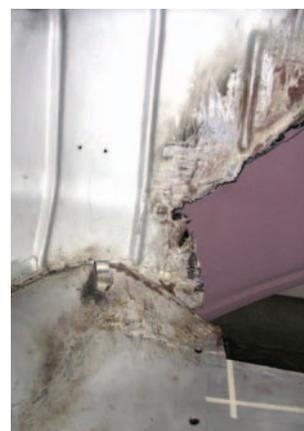
Photo #10: There are four vertical beads rolled into the original inner trunk wall for strength. The rear cut line on the trunk floor, marked here with tape, was just to the rear of the forward most (fourth) bead. This was a conservative initial position for the cut. The cut will be moved rearward later to allow fine tuning of the height of the new tub. This rear trunk floor cut is perpendicular to the frame.

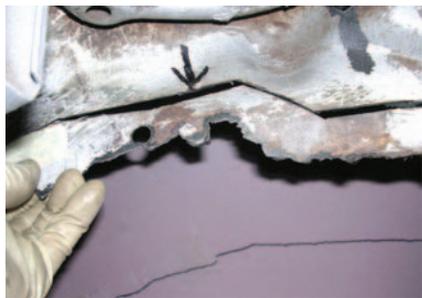
Photo #13: As the rusted metal was removed we found the original location of the baffle. The arrow marks that location, just forward of the hinge box on the outboard side of this panel. You

will want to mount the new baffle in this same location.

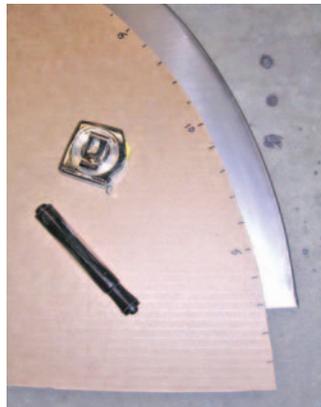
Photo #14: Make a template of the tub cheek using the carton that the tub kit came in. Trace the shape of the metal cheek onto the carton and cut the template out with a sharp knife. Make a mark every inch along the circumference of the template.

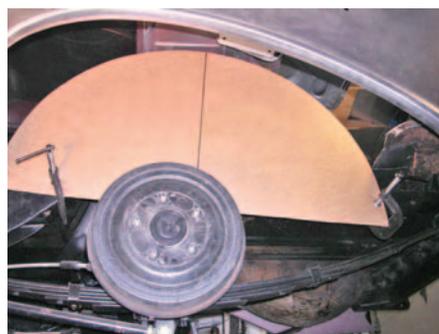
Photo #15: Raise the cheek template up into the opening in the trunk floor with the inch markings on the inboard side. Use C-clamps to hold the template to the frame. The center line of the template

has been marked as a reference. Conventional wisdom is that the center line of racing tubs should be vertical and centered on the rear axle. This gives maximum vertical clearance for suspension travel and symmetrical front and rear tire clearance. We instead placed the center line behind the rear axle and at an angle to vertical. This minimizes intrusion of the tub into the passenger compartment and retains proper rear quarter window clearance, while still leaving plenty of tire clearance. The upper surface of the new tub should end up just below the trunk hinge box, although it sits lower than in this view. You can just see the hinge box at the top center of this photo. The conservative rear trunk floor cut made earlier can now be reassessed. By gradually moving this cut line to the rear, the cheek template can rise higher in the trunk. The goal is for the cheek template to end up just below the trunk hinge box.

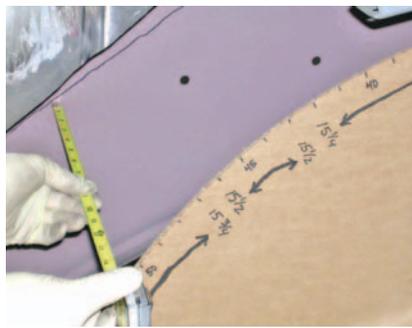
Photo #16: Measure from the cheek template to the inside of the quarter panel at every inch mark around the circumference. Keep the tape measure perpendicular to the cheek template and parallel to the ground.

Record these measurements on the cheek template. These measurements determine the width of the band.

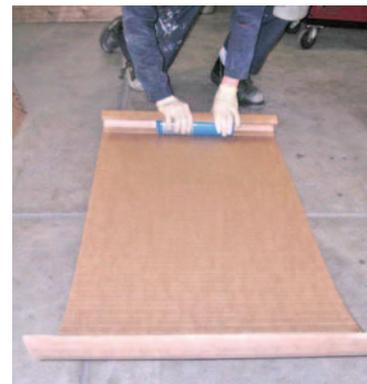
Photo #17: Curl the band template provided in the kit by rolling it around a cylindrical object. A propane bottle was used here.

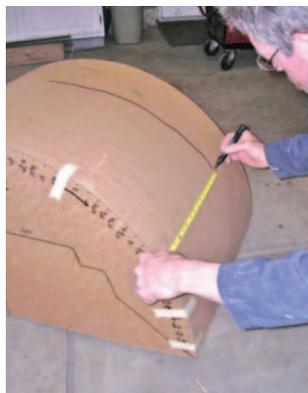
Photo #18: Remove the cheek template from the car. Use masking tape to attach the band template to the cheek template. Transfer the recorded measurements to the band and connect them to mark a cut line along the band. In order to make trial fitting of the tub template easier, we cut the band about one quarter inch short of this line.

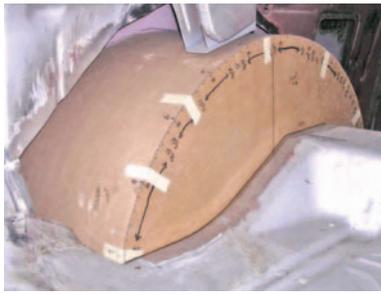
Photo #19: Working from above, place the tub template in the trunk and attach it to the frame with C-clamps. The top of the band template should end up about 1/2 inch below the hinge box. The tub template can be raised by gradually increasing the length of the trunk opening. Making new rear trunk floor cuts will allow this. Notice the final cut in this photo is about 3" to the rear of the conservative initial cut. This final cut is just ahead of the third trunk wall bead.

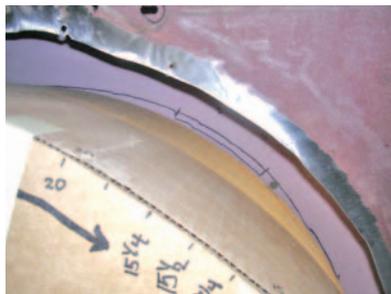
Photo #20: When the tub template is properly located it will be below and to the rear of the window dimple marking. This will allow proper operation of the rear quarter window. Also make sure the template

position will not interfere with holes used to attach the exterior stainless trim.

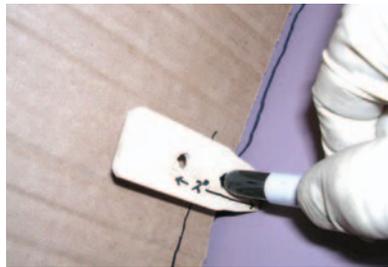
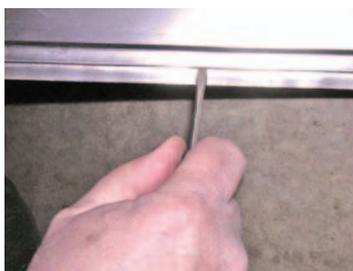
Photo #21: A contour marking tool allowed us to make a more accurate band fit. The tool was made from a wooden paint paddle with holes drilled at one and two inches from its end.

These holes allow the tip of a marker to pass through the tool. The contour tool was slid along the inner quarter marking a line on the underside of the band template. This marked line followed the exact contour of quarter panel and was exactly one inch from that surface. If the band template was cut too narrow, the two inch hole on the tool could be used instead. With the tub template in its final position this is a good time to mark the inboard side of the cheek template along the top of the trunk floor.

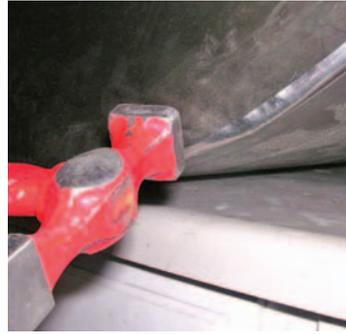
Photo #22: Next we assembled the actual steel tub by mating a band to a cheek. We rolled the band around a spare tire to give it a bit of a curve. Make sure the open part of the Pittsburgh seam is to the inside of the curve. We also ran a small screwdriver down the seam to make sure it wasn't pinched flat by the curving process. We used a hammer and dolly to check the lip on the curved edge of the cheek to

make sure it had a nice 90 degree angle. The lip of the cheek fits into the seam on the band, so checking these areas first is recommended. We also recommend at least two people for handling this awkward job.

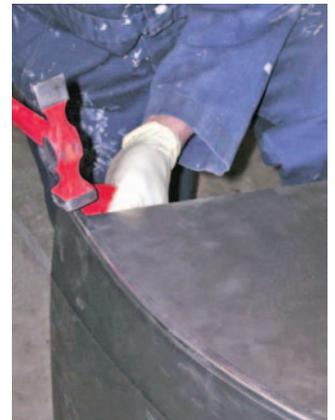
Photo #23: We slid the end of cheek lip into the band seam and bent the band up slightly with a body hammer, locking the cheek into the seam. Tap the seam up just enough to hold the cheek and band together. Gradually work your way down the seam locking in a few inches at a time.

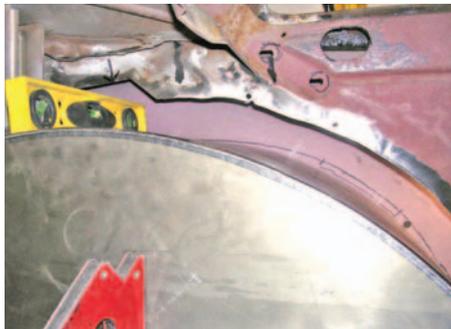
Photo #27: Tabs were made by cutting out triangle shaped pieces using tin snips. The triangles were one inch deep, one inch across their bases, and one inch apart.

A pneumatic hole punch was used to make 3/16" holes for spot welds, two inches apart. Pliers were used to bend the tabs down along the first contour line and then the tabs were flattened with a hammer and dolly. The cardboard template shown was used to keep the tab spacing consistent.

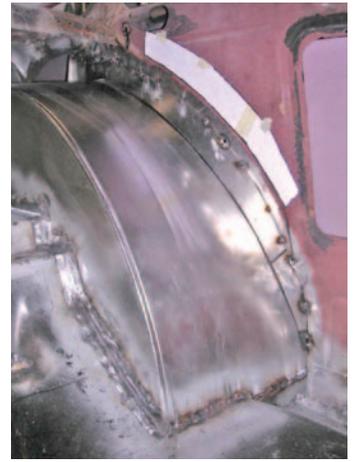
Photo #34: A pedestal was constructed to support the trunk hinge box and to strengthen the tub. The sides of the pedestal extend the walls of the hinge box down to the band. Paper templates were used to create the four sides. The templates were transferred to 18 gauge sheet metal and the pedestal sides were tack welded to both the hinge box and the band.

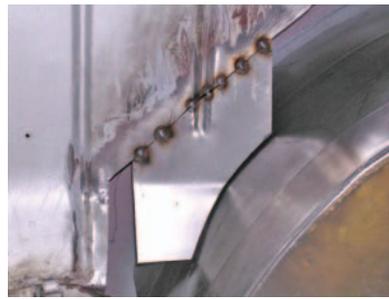
Photo #35: The inner quarter panel was then rebuilt. This panel consists mostly of flat sheet metal. Paper templates were made and metal patches were cut out of 18 gauge sheet metal. One of the templates is shown taped to the quarter panel just above its patch. These patches were tack welded into place on the quarter panel. Once tack welded into place they could be adjusted, tack welded to each other, and tack welded to the band. The patch at the peak of the band was welded to the new baffle. The level of finish for these welds is a matter of personal preference. These will be covered by upholstered side panels so perfect finish work is not needed.

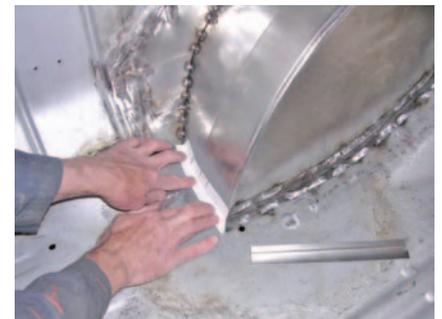
Photo #36: The repair of the inner trunk wall was more complicated since patch panels are not available for sedan body styles. The end of the fourth bead was compromised by rust and had to be cut away. We began by fabricating this patch panel first. Starting with a piece of 18 gauge sheet metal approximately 6 x 12 inches, we marked a straight line ending in a "T" to serve as a guide. Using the small 1/4 inch die on a bead roller, we rolled a bead that ended at the "T". With a straight bead established, we moved on to larger dies, making the bead wider and deeper. Since most of you may not have a bead roller, this shape can also be formed with a ball peen hammer and some elbow grease.

The patch panel was then tack welded into place. The new bead ties in nicely to the original bead above it. The remainder of the trunk wall pieces were made by similar processes and then welded into place. If you are working on a 2-door hardtop or convertible, you can avoid making your own patches and use repair panels **P/N 31-317** and **31-318** here.

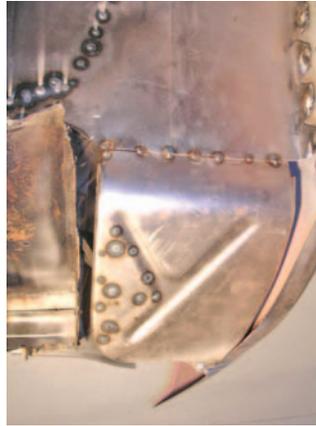
Photo #37: With the trunk wall and inner quarter repaired, flanges should be made to attach the front and rear edges of the band to the floor. Shown here is a paper template that was used as guide to make the cuts and notches on the flange material. Holes were punched

in the flanges and they were spot welded to the band and the floor. With the tub tack welded in place, and all the flanges in place, the tub was then welded with a continuous bead all the way around the trunk floor. We made sure to weld only in short bursts to keep the heat down and to avoid warping the band or the cheek.

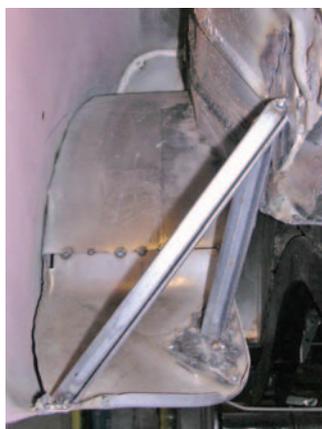
Photo #38: With the tub finished we then tackled the rear wheelhouse extension. The extensions, P/N 31-89 and 31-90, are sturdy pieces of metal and they do take considerable abuse. The extension is also the lower stabilizing point for the rear quarter panel, keeping the quarter panel from flexing and fatiguing. Simply welding the extension to the thin 24 gauge tub band without bracing of some kind wouldn't have been stable enough. This would be especially true if the band was not spot welded to the inner rear quarter and was held on only by sealant. We first reinforced the extension by welding two pieces of 12 gauge sheet metal to the back side of the extension. These will not be visible from most angles. The triangular reinforcement piece is evident from the spot welds visible on the inboard underside of this extension. A second piece of 12 gauge was welded to the upper surface of the trailing edge where the extension would be welded to the inner surface of the rear quarter panel.

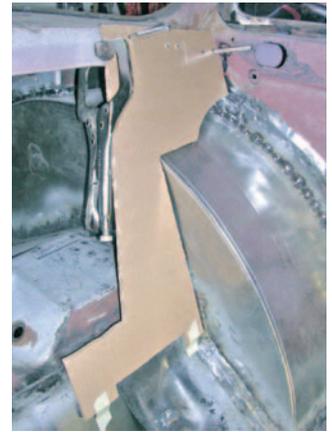
Photo #39: A piece of 12 gauge approximately 3 x 4 inches in size was welded to the outboard surface of the inner trunk wall. This piece reinforced the wall and spread the load over a larger area. Braces of 1/8 x 3/4 x 3/4 angle were welded in place between the trunk wall reinforcement and the reinforced portions of the extension. This bracing will keep the extension in place, will prevent the rear

quarter panel from flexing, and will take the strain off the band. Be sure to mock up the gas tank filler tube to check clearances before welding these braces in place. The right side wheel tub was then constructed using techniques similar to those shown in the steps above. When the right side hinge box support was removed, the car lost the forward mounting bracket for the original equipment jack. I have chosen to forgo the original jack for a more compact modern jack that will be hidden behind custom trunk panels. For that reason the rear jack bracket on the trunk floor was also removed.

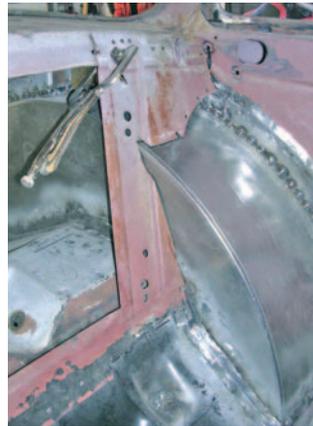
Photo #40: The seat back support was then modified to fit around the new larger wheel tubs. I began by tracing the left side of the support onto a piece of corrugated paper. I cut out the template which included the holes that marked the original spot welds. The right side was tacked in a similar manner at the same time.

With the support template positioned by alignment tools through the original spot weld holes, the template was trimmed to fit nicely around the new wheel tub.

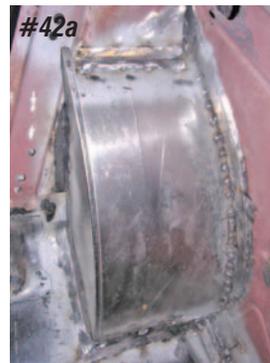
Photo #41: The template outline was then transferred to the support and the excess metal was removed with a cut-off tool. Additional trimming was necessary to give the best fit of the support to the tub. The support was then welded into place using the original spot weld holes in the package tray and along the rear of the floor.

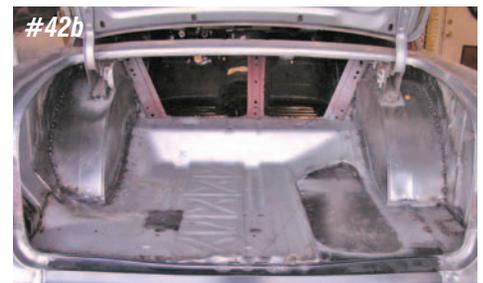
Photo #42a & 42b: Flanges were made to fit along the vertical inboard side to the cheek as well as across the top of the band. A piece of sheet metal was added to the support to fill in the quarter circle shaped gap left by the missing original inner wheel tub. This increase the flange length and strength across the top of the band. As one can see by the amount of metal cut from this

support, modifications will need to be made to the rear seat bottom and backrest frames, the seat upholstery, and to the side panel. With the metal work

complete, a generous bead of autobody sealant along the underside of the Pittsburgh seam and along the edges of the band will keep out the elements. The underside of the tubs can then be painted or undercoated for a finished appearance. The only question now is how wide do we want the new rear tires to be? Good Luck. ▼
