Tech Help

Repairing lower door rust

Door Repair and Re-skinning

Re-skinning the Door

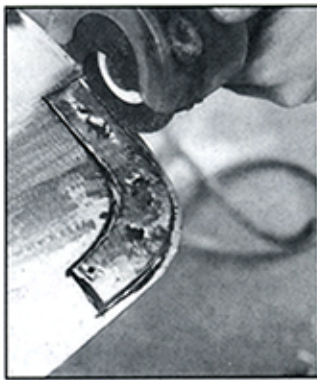
Photo #4

2. Areas with significant rust should be cut out and replaced. The lower rear edge of our door was very rotten, so the rusted area was removed with an air cut-off tool. (See Photo #4.) Be very careful not to disturb the actual edge of the door, if possible. Refitting the door and achieving proper gaps will be far easier if the edges are not disturbed. Cut out the area and remove the bad metal. (See Photo #5.) It is always easier to cut any rusted areas out using straight line cuts; however, we could not in this area because the rust was so close to the edge of the door.

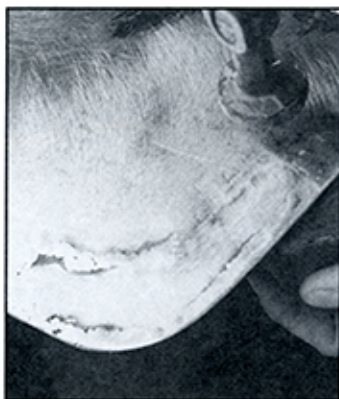
Photo #7

3. Using the rusty piece that was removed from the door, cut a repair panel the same shape out of original gauge steel (we like to use a junk hood to remove steel patches from) and trim it to a size that is just slightly smaller than the area to be repaired. Carefully position the patch in the door and tack weld it into place using a MIG welder on low power. (See Photo #6.) Solid weld the piece into place a stitch at a time, being careful not to over-heat the door metal. Keep in mind that the larger the area to be cut out is, the more likely it is that the door metal will distort when welding. Be very, very careful to weld a little at a time and allow the door metal to fully cool to avoid distortion! Once the piece is solid welded, grind the welds smooth and hammer and dolly out any distortion. (See Photo #7.)

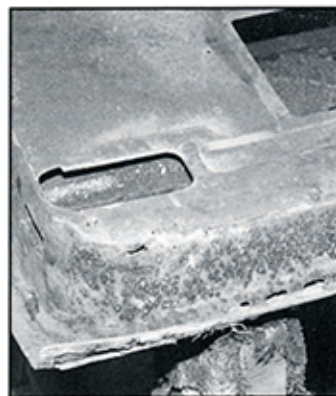
Photo #15

6. Some doors are too heavily rotted to be patch repaired as we did our driver side hardtop door. [Photos #15 and #16](#) show the bottom of our passenger side hardtop door that was very heavily rusted. The inner door bottom was very badly rusted, as well as the lower outer skin. There was no way to properly repair this door without replacing all of the rusty sheet metal. Our door will receive an inner door bottom, [Part #31-132](#) and a full door skin, [Part #31-30](#).

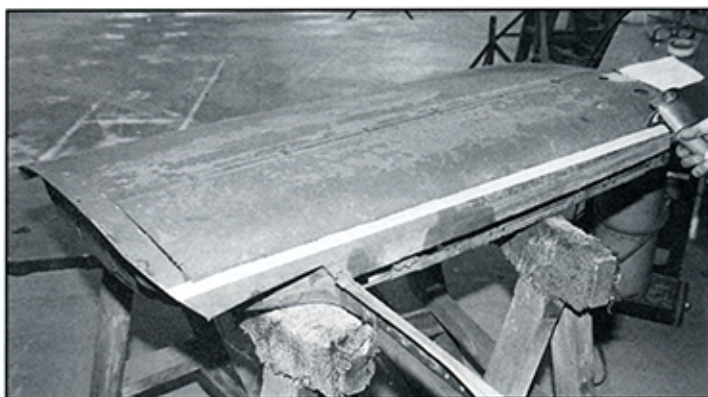
Photo #17

7. No cutting or removal of the original sheet metal should be done until the new panels have been obtained and compared to the areas to be repaired. This will prevent you from removing too much metal and having to start over with another door or fill in any gaps that may be left! Once you have obtained the new repair panels, remove the original skin from the door. If you are installing a full door skin, remember that the top inner beltline stainless lip is not included on the replacement panel. We chose to cut the door about 3 inches down from the top edge. (See [Photo #17](#).) Once the old skin is removed, your door will look like ours does in [Photo #18](#).

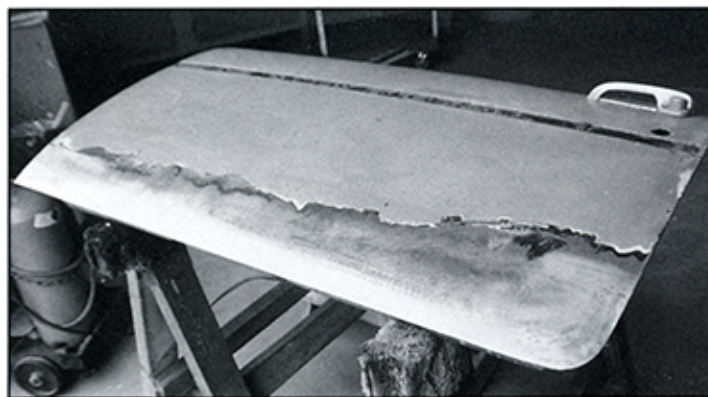
Photo #13

5. Any areas that have only small pinholes should be welded up and ground down so that the entire door bottom has been repaired. Once the door has been fully repaired, it should appear as ours does in Photo #13. After all welding and grinding is complete, apply a thin coat of All-Metal body filler, Part# 49-28 to the repaired areas and sand smooth. (See Photo #14.) Check the fit of the door on the car to be certain you have not disturbed the edges of the door. The inside of the entire door should be treated with Part #49-51 POR-15 metal ready spray and Part #30-52 POR-15 rust preventative paint to prevent any future rust. Finish the bodywork, prime and paint the door.

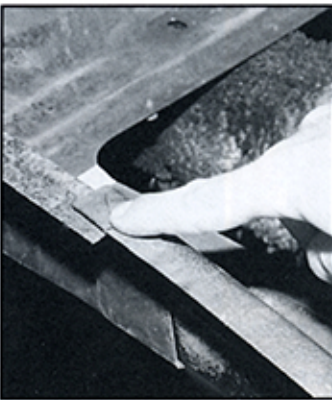
Photo #25

10. Remove the door frame assembly from the car for permanent welding. At the rear edge of the door, the new panel overlaps the original frame on the outside. This small area should be cut out so the edge can be butt welded. (See Photo #25.) This will allow the new skin to fit the edge of the door frame properly. At the front edge of the new door bottom, there will actually be a small gap at the edge seam between the new piece and the original door frame hinge area support. (See Photo #26.) Clamp the edge to achieve proper fit and stitch weld the entire new door bottom in place. Install the door assembly on the car again and check the edges for proper fit. (See Photo #27.)

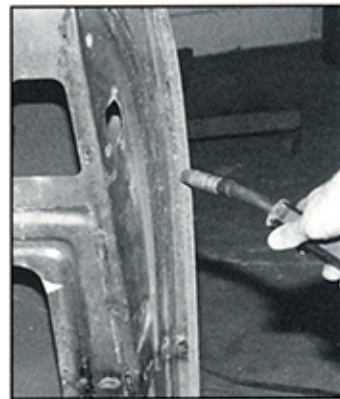
Photo #39

13. Once the door is fitting properly, tack weld the skin to the frame in several places around the inner edges to prevent the door frame and skin assembly from twisting out of shape as you continue to work. (See Photo #39.) Tack the top edge of the door skin to the top edge of the original door skin in five or six places. Continue tacking until you have tacked it every inch or so. (See Photo #40.) Being careful not to overheat the door, solid weld, grind and finish the top of the skin. Finish spot welding the inner edges of the skin every three inches and finish all bodywork. Remove the door handle inner reinforcement plate from the old door skin (See Photo #41) and spot weld it to the inside of the new door skin. Also remove the lower door panel retainer strip from the original door bottom (See Photo #42) and spot weld it to the new inner door bottom. In order to locate the stainless holes in the new door skin, make a template from the original skin (See Photo #42), and transfer onto the new skin. Drill and file the new holes in the proper locations.
