YOU GAN DO IT EASY UPGRADES by Randy Irwin

1955-57 BELTLINE STAINLESS STEEL INSTALLATION

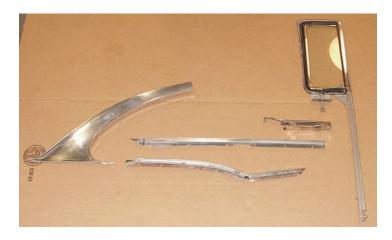
Photo #1a & 1b & 1c: The dogleg moldings are held to the body with

three #6 button head sheet metal screws behind the sail panel. One #6 countersunk sheet metal screw at the front of the molding is trapped between the upper quarter glass stainless channel and the body with two #6 button head screws. In addition, the molding is attached to the body at the rear under the rear glass rubber via a rectangular metal tab that is screwed to the pinchweld.
